# National Transportation Safety Board

## **Environmental Response Group Chairman's Factual Report**

Description: *Cosco Busan* Allision with San Francisco-Oakland Bay Bridge  
Commodity: Intermediate Grade Fuel Oil (IFO-380)  
Location: San Francisco Bay  
Date/Time: November 7, 2007, 08:30 PST  
NTSB No.: DCA08MM004

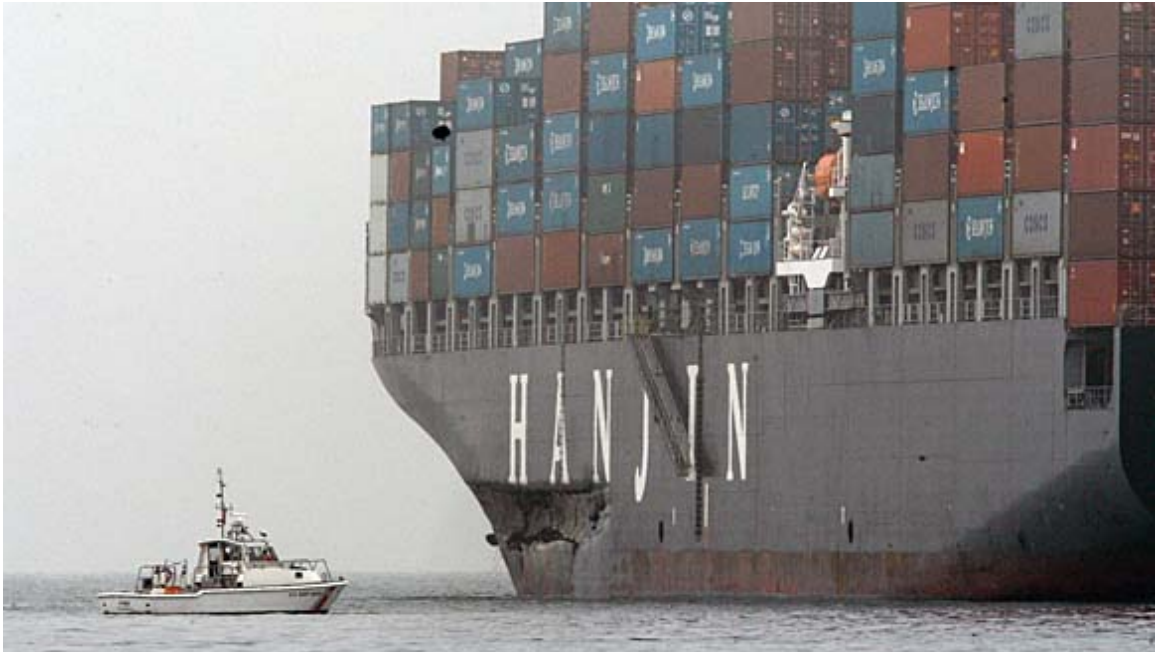
FIGURE 1 – PHOTOGRAPH OF DAMAGE TO THE *COSCO BUSAN*
